## New Style Precut Blade and Blade Retainer

Effective immediately, the Blade Retainer Kit CG030172K supersedes all previous Retainers and Retainer Bolts and should be fitted to all CG03 Cutter Grinders (with the exception of the CG03DF where it is not required and must NOT be fitted). This new blade retainer provides extra strength to minimise flexing and possible breakage of the Precut Blade in the CG03.

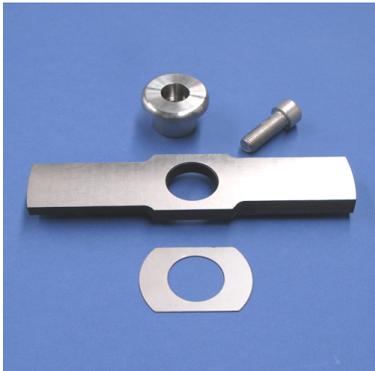
<p data-bbox="1059 958 1433 992"><b>CG030155 + CG030172K</b></p> <p data-bbox="1043 1003 1449 1061">(Shim CG031071 may be required to add extra clearance under the Precut Blade)</p>
<p data-bbox="204 1104 491 1137"><b>SUPERSEDED TYPE</b></p> <p data-bbox="161 1149 534 1176">(for all models except CG03DF)</p> <p data-bbox="268 1187 427 1220"><b>CG030151</b></p>	<p data-bbox="651 1104 943 1137"><b>SUPERSEDED TYPE</b></p> <p data-bbox="608 1149 986 1176">(for all models except CG03DF)</p> <p data-bbox="715 1187 879 1220"><b>CG030171</b></p> <p data-bbox="630 1227 967 1254">(inc ZCA1640 Blade Retainer Bolt)</p>	<p data-bbox="1098 1104 1390 1137"><b>SUPERSEDED TYPE</b></p> <p data-bbox="1054 1149 1433 1176">(for all models except CG03DF)</p> <p data-bbox="1066 1187 1422 1220"><b>CG030151 + CG030171</b></p>

- Check the Precut Blade for any sign of damage to the cutting edges caused by rocks or metallic objects in the cane supply. Resharpen or replace as necessary.
- Check the Precut Blade for any signs of cracking particularly in the centre hub area. This may require removal of the Blade Retainer for proper observation. If any cracks are observed, replace the part immediately. **Do NOT operate if any cracking is evident.**
- Check the Precut Blade for any signs of excessive wear of its cutting edges or surfaces. Regrind or replace as appropriate.
- Check that the Blade Retainer Bolt is fully tightened by using the correct Allen Key and the Locking Bar to ensure adequate torque.
